PRELIMINARY VIBRATION AND FLUTTER STUDIES ON P-47 TAIL

By Theodore Theodorsen

Langley Memorial Aeronautical Laboratory
Langley Field, Va.

MEMORANDUM REPORT

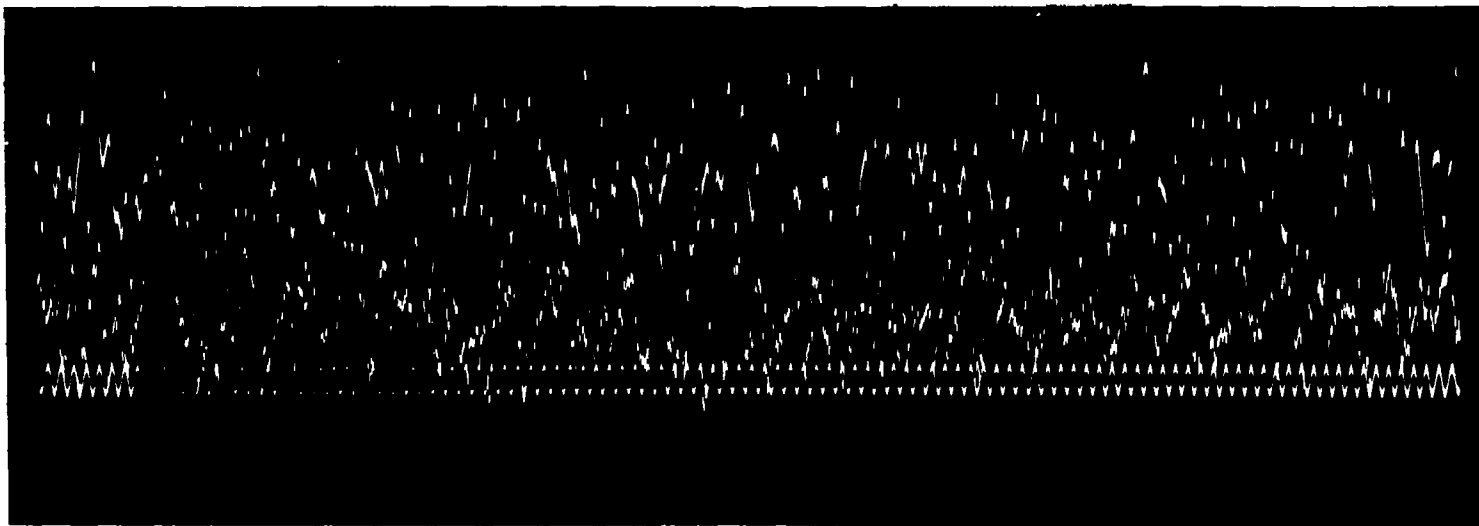
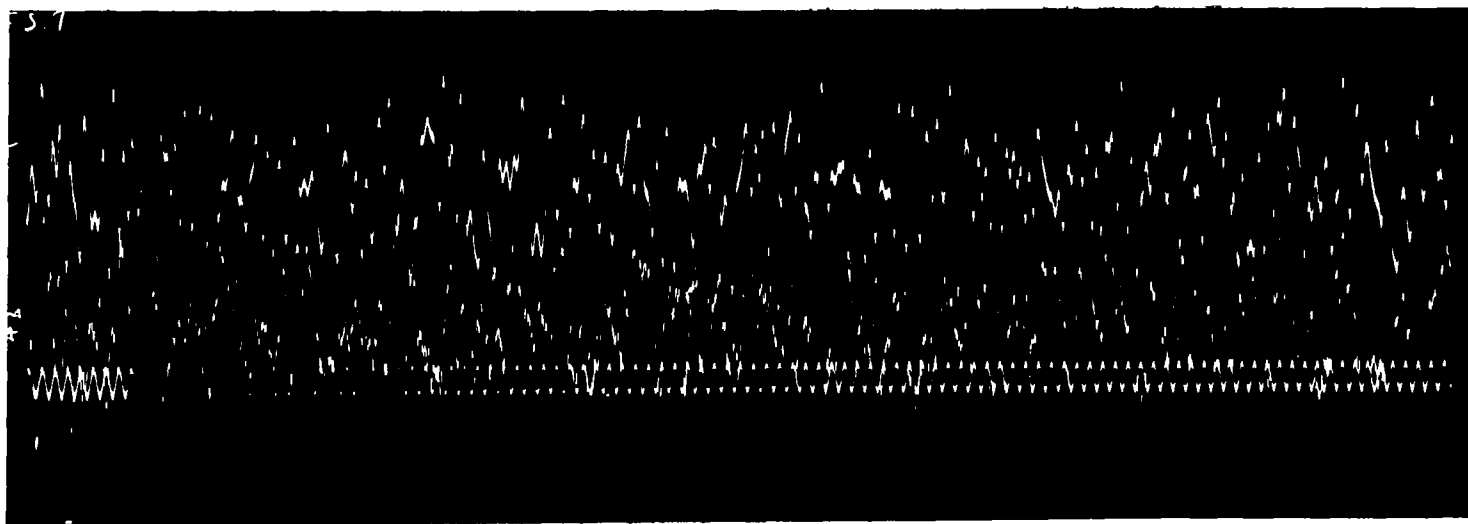
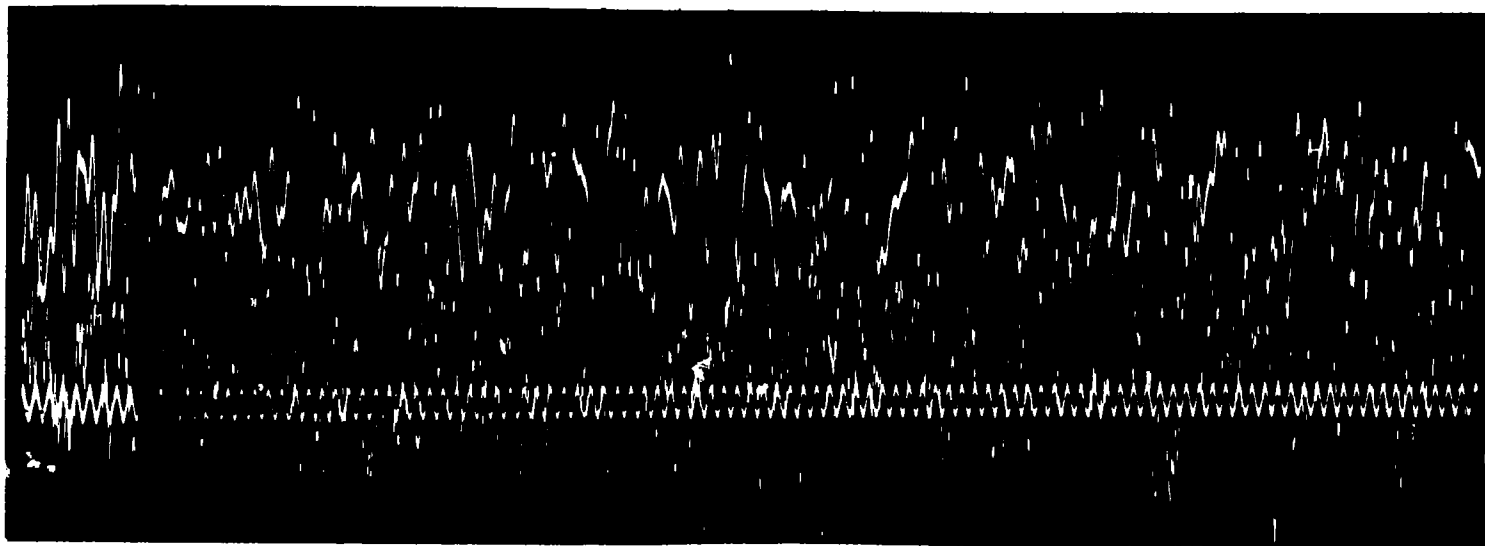
Figure 1.

amplified and recorded on an oscillograph. A sample record taken at 85 miles per hour is given in figure 1. The upper trace is obtained on the wire strain gage or "fish tail" and the lower record is taken with a hot-wire pickup, both in the air stream immediately behind the rudder. The timing wave at the bottom is a 300-cycles-per-second sine wave.

These records showed only one outstanding response frequency very nearly of the same rate as the timing wave or 300 cycles per second.

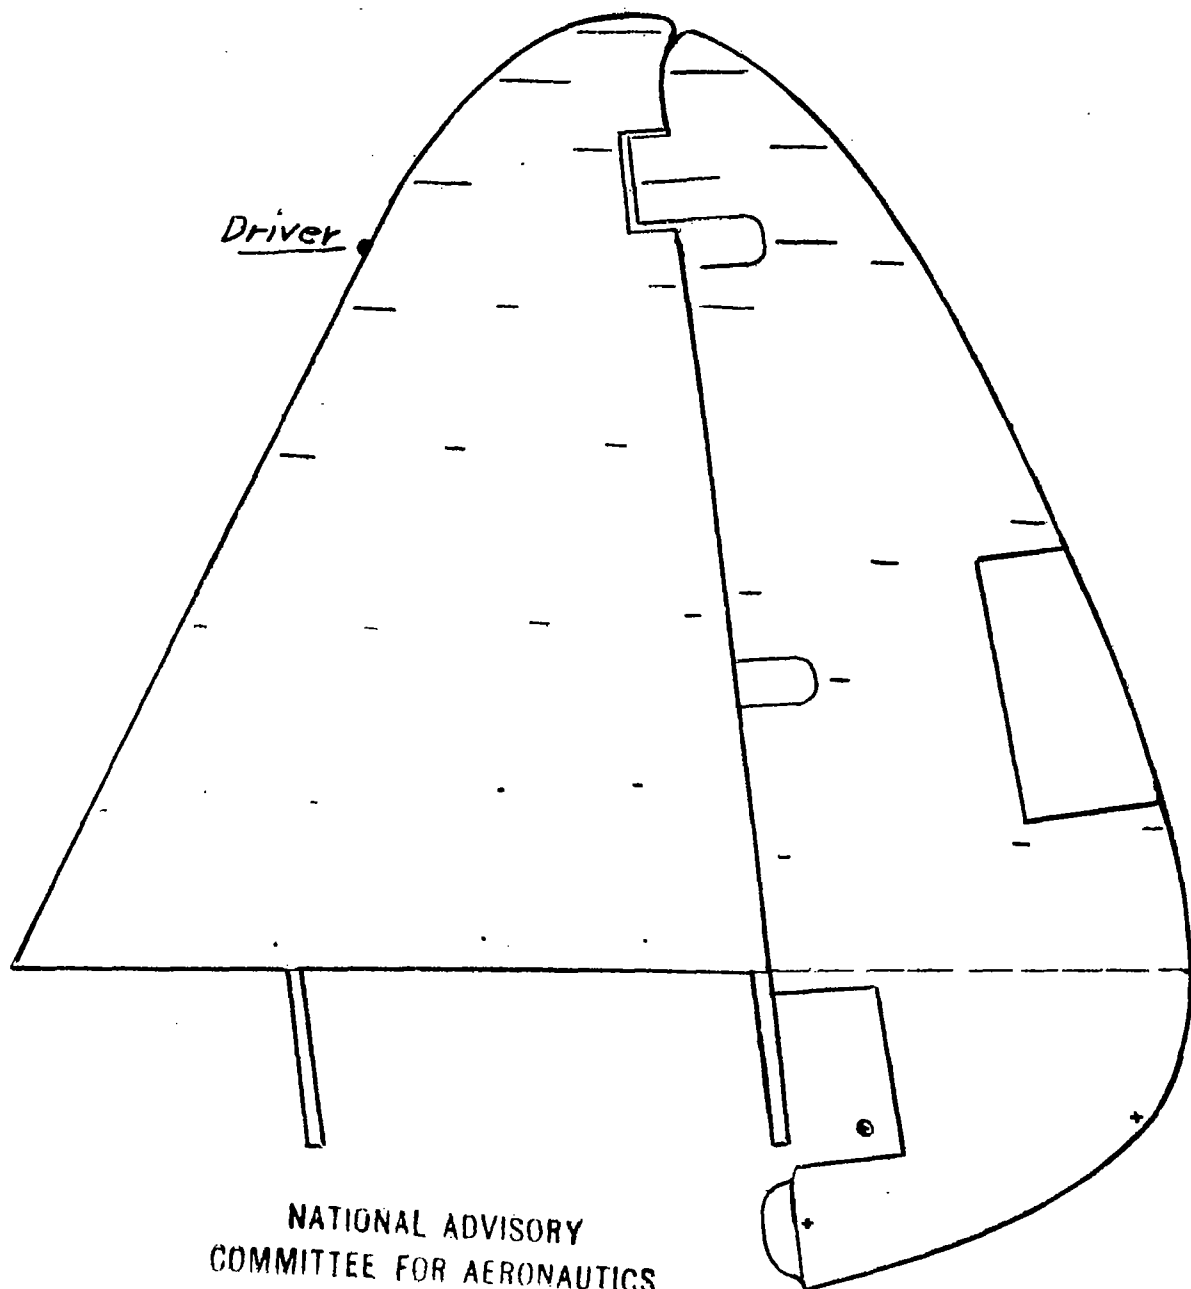
FIGURE 2

In these figures, the plus and minus signs designate the phase, with the size of the signs approximately indicating the magnitude of the motion at each point. For instance, in figure 2, it can be noted that the entire surface is in the same phase, with the largest deflection near the top as

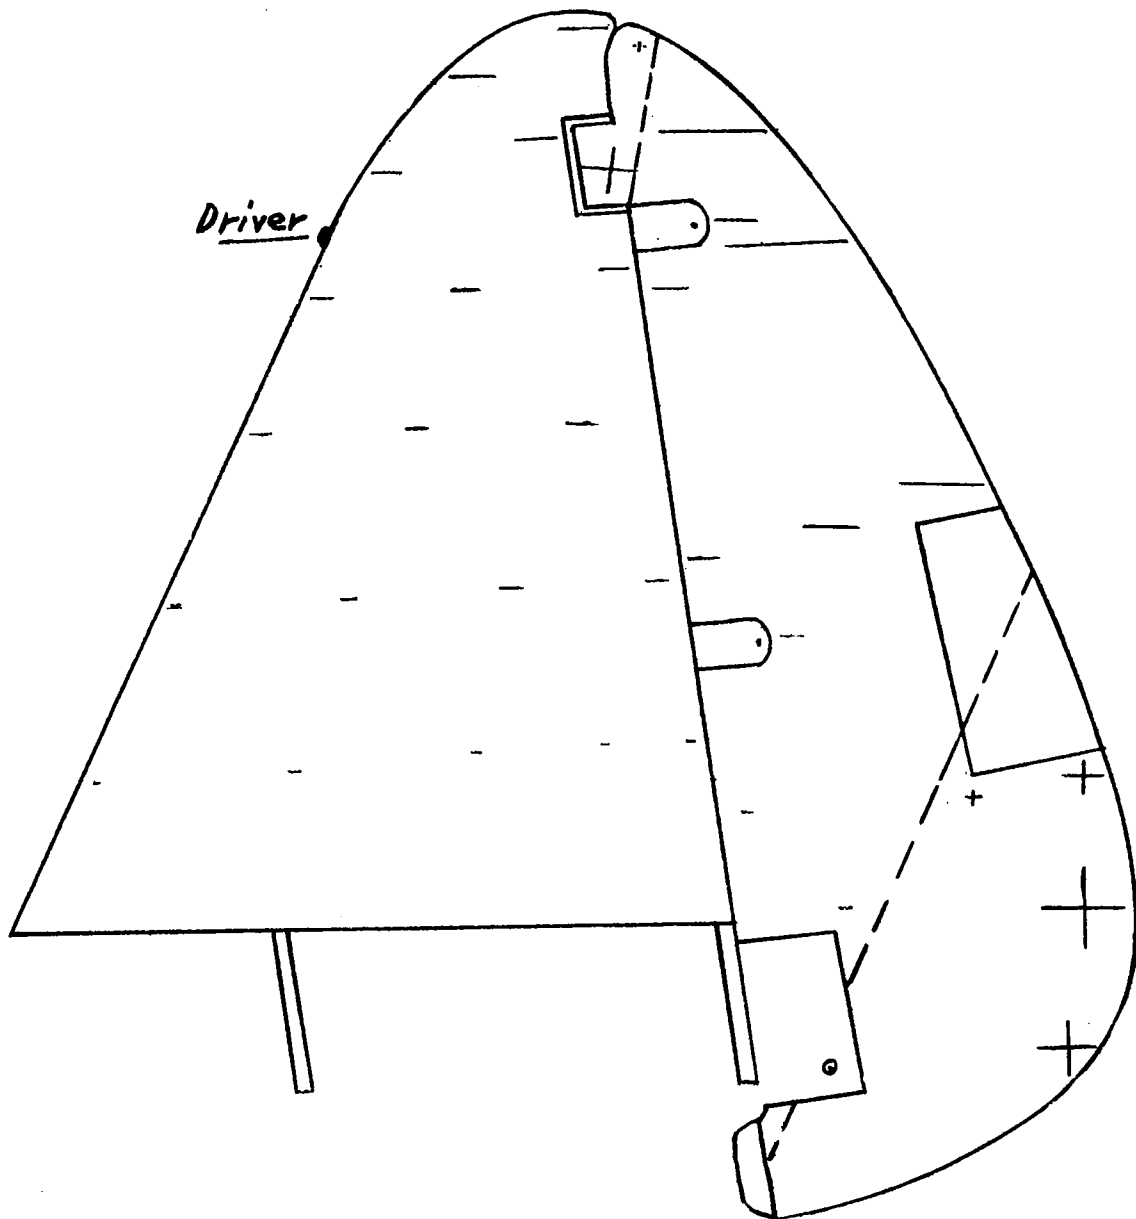
FIGURE 3.

expected. In the second figure (fig. 3), it is seen that the entire unit again is in phase except for the upper balance weight and the lower rear corner of the rudder.

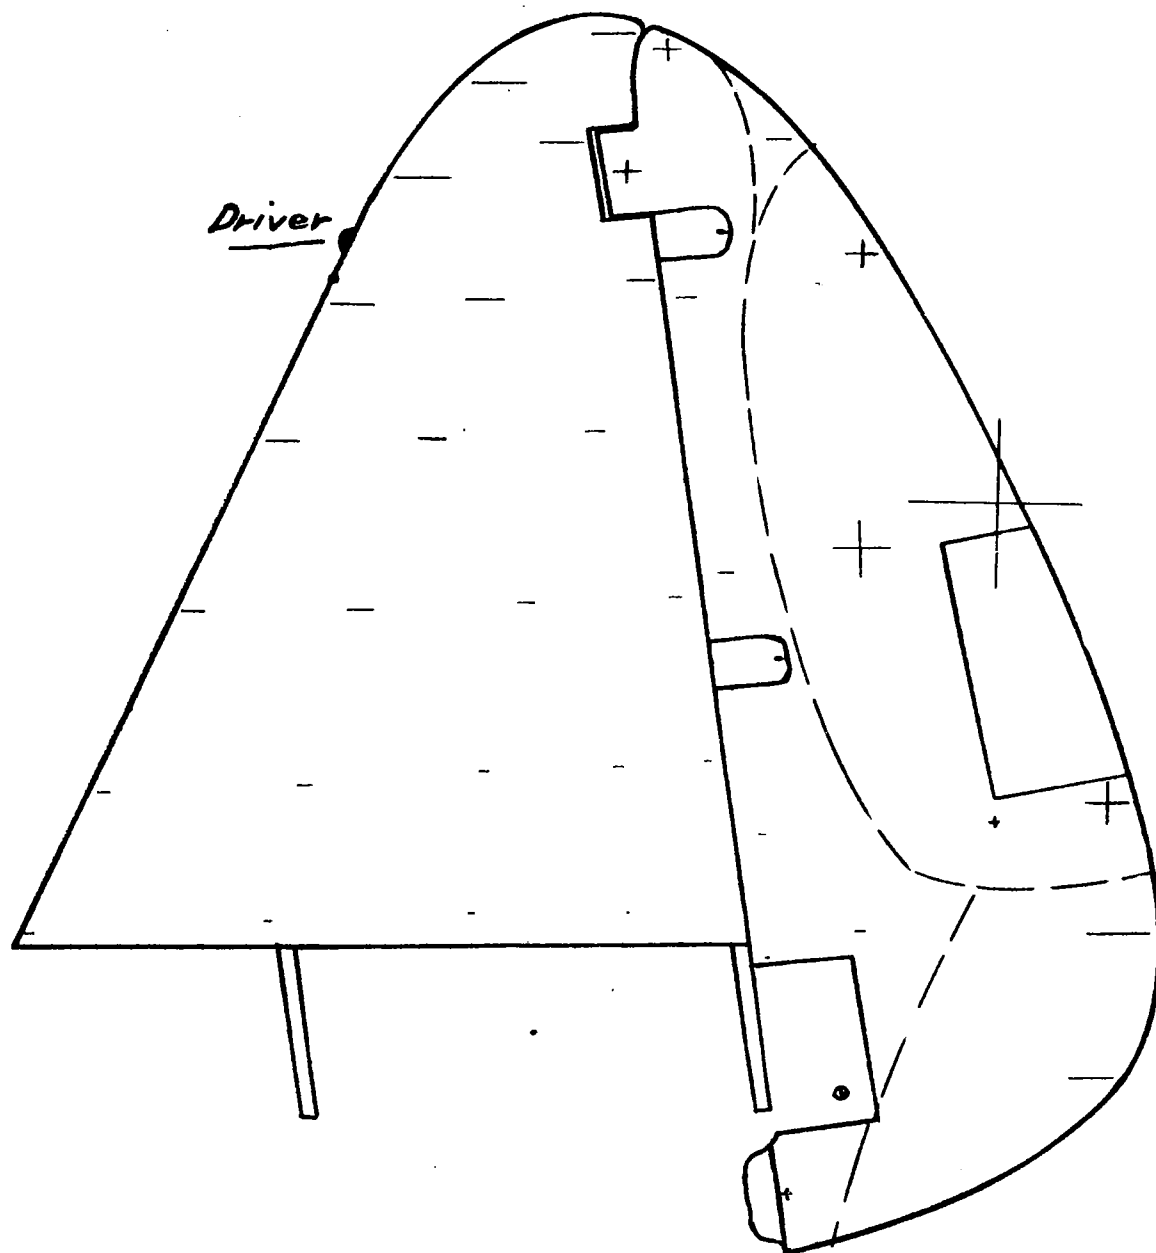
FIGURE 4.

In the next figure (fig. 4), which case was originally believed susceptible to flutter, it is seen that there is a large deflection near the upper end of the tab. The top balancing weight is out of phase. Responses at 75 and 94 cycles per second were also recorded. (See figs. 5 and 6.)

a higher mode of the type shown in figure 4 was involved. The studies showed that not much margin of safety remained against flutter in this mode. Since the records give no evidence of this mode of a frequency of 50 to 60 cycles per second, but showed a higher mode of 146 cycles per second, detail reference to these calculations will be considered unnecessary at the present stage.

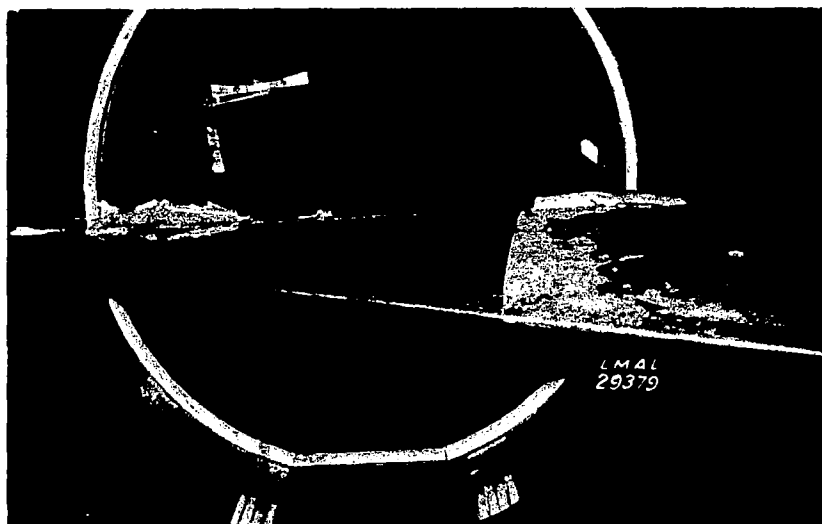
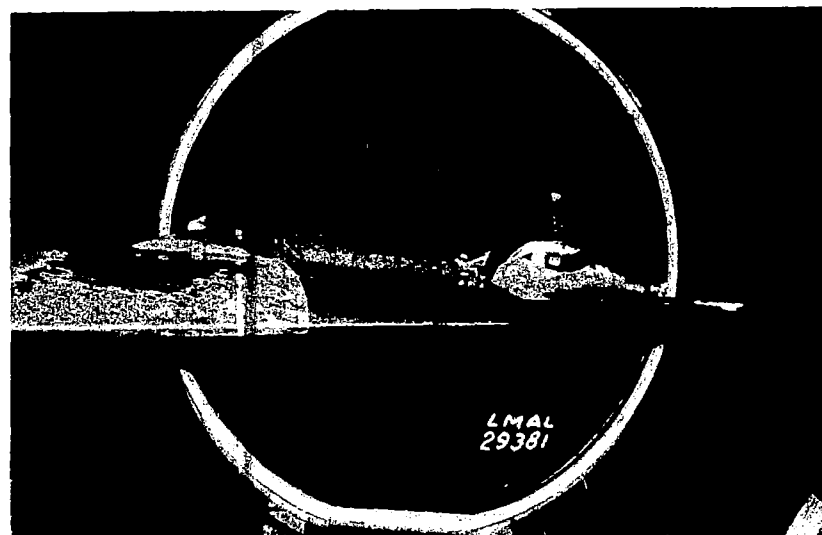
The rudder failed at 468 miles per hour (true speed). The temperature of the air was $t = 111^{\circ}$ F and the density $\rho = 0.00182$ pounds per cubic foot. The upper portion of the rudder beyond the tab was demolished, the trailing edge and most of the fabric torn off, and the ribs badly twisted with the upper one torn out. The act of disintegration of the rudder was observed by several persons. It did not appear to be violent probably due to the high frequency involved. Prior to the explosion the rudder appeared rather normal except for a distinct swelling up of the skin between the ribs, most prominent near the base but also evident over the front portion of the tip of the rudder. This swelling started at about 300 miles per hour. The installation was not conveniently arranged for visual observation. Evidently the entire upper section of the rudder swelled up considerably a few seconds before the final destruction. Whether the structure at this time exhibited a possible large amplitude and high frequency vibration, or that it already had broken down, was not evident from observation. The process of destruction lasted only 3 to 5 seconds. The photographs

(fig. 7 through 11) show the destroyed rudder in the tunnel, and figure 12, the rudder separately with the broken pieces of the trailing edge arranged in place by small wires.

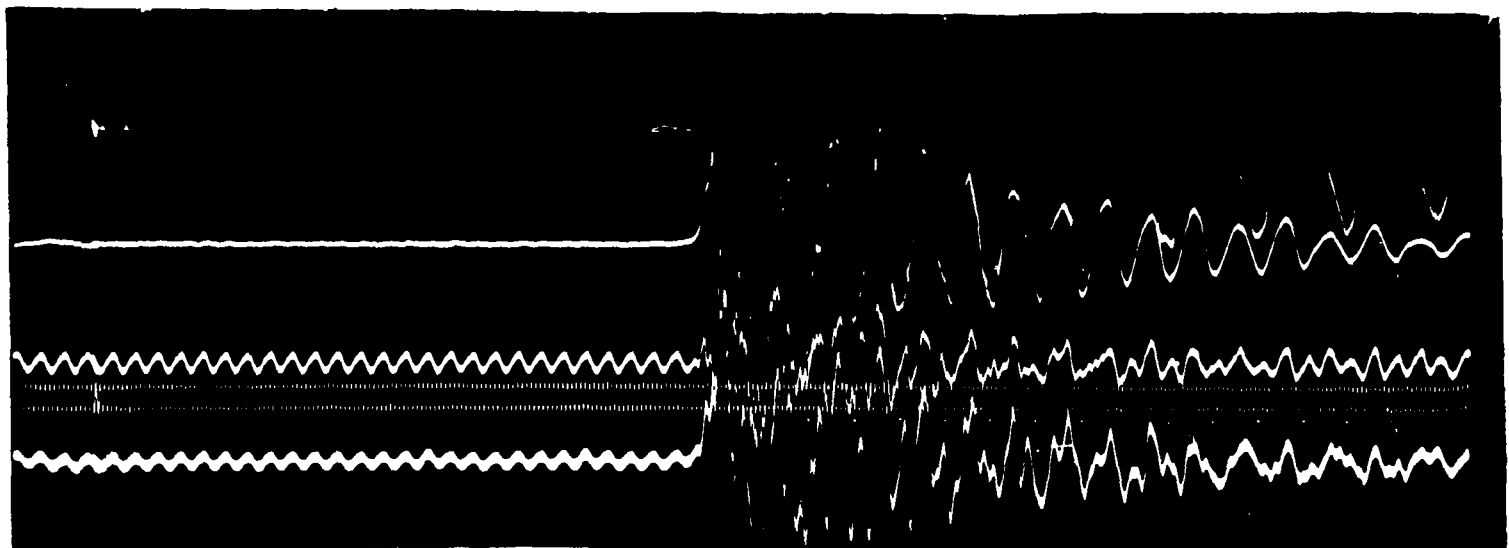
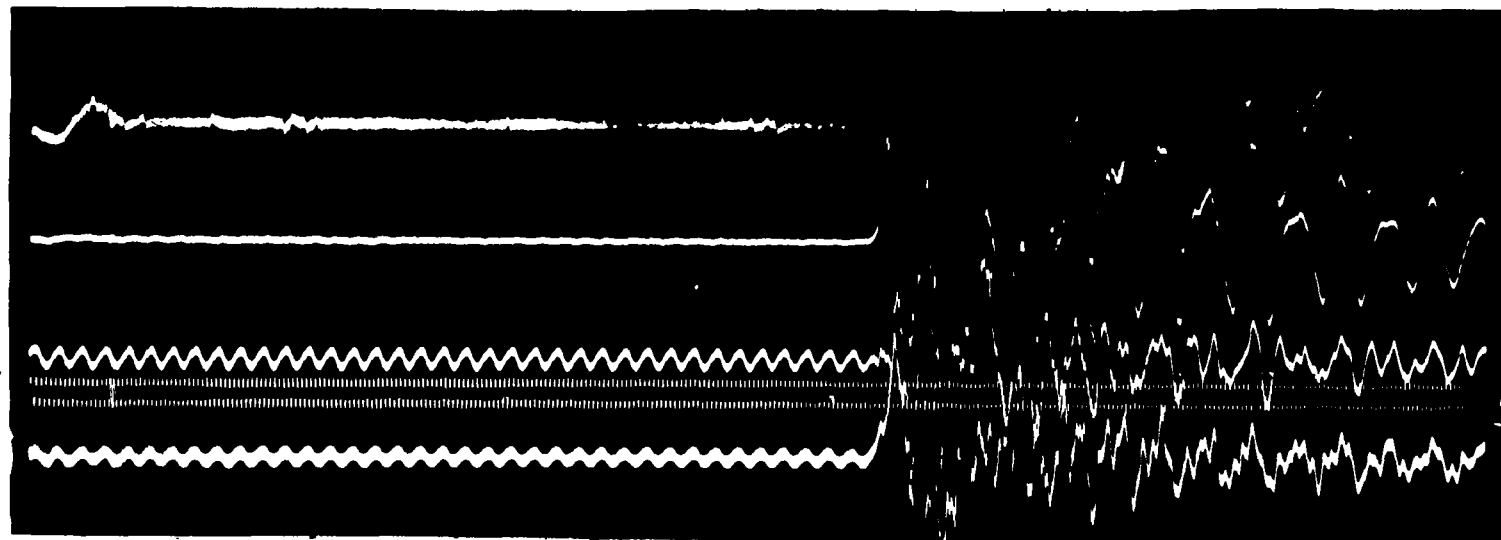
Figure 13.- Concluded.

The first interesting observation can be made in regard to the apparent rudder damping. The trace, G, shows this most plainly. At zero airspeed (figs. 13(c) and (d)) the records show a small damping as expected. In figure 14, taken at approximately 200 miles per hour, it is noted that the large deflection in G, obtained in each case by releasing the trip mechanism, appears nearly critically damped. In R and B about three successive excursions are visible;

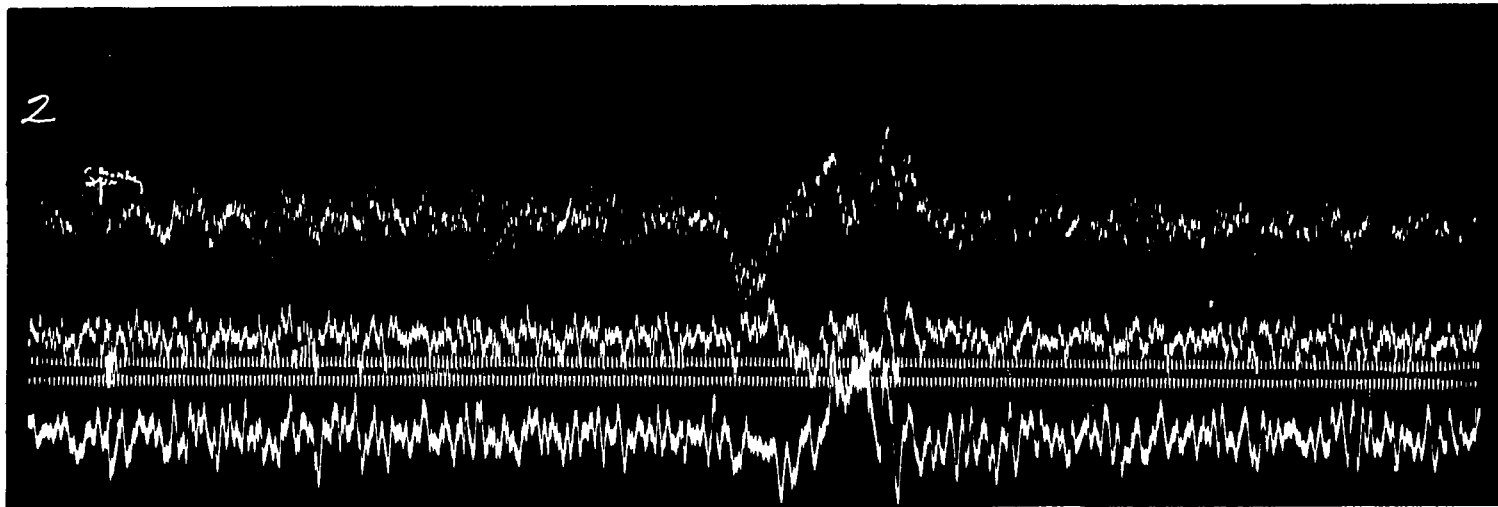
Figure 16.

Y shows little response. Records in figures 16 and 17 taken at 300 miles show a similar damping. At 350 miles per hour (fig. 19), the response, B, is still well damped, but the torsion element, B, and the rib element, B, show several successive waves after each tripping of the rudder (figs. 22 to 26).

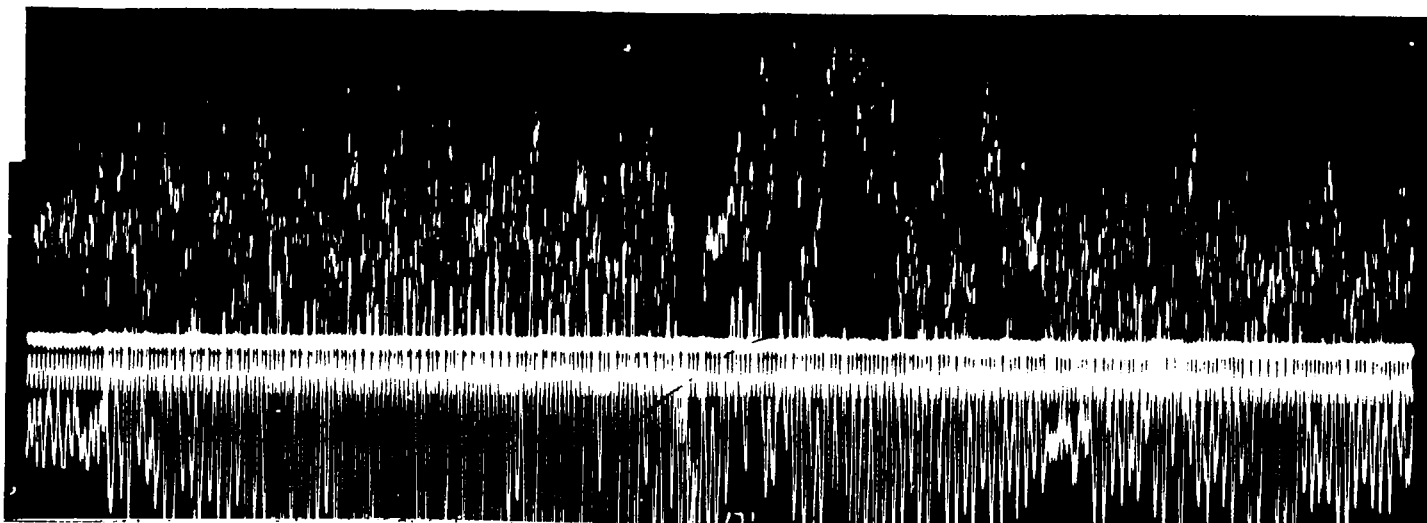
Figure 30.

This high frequency was in evidence probably for 3 to 5 minutes before the failure of the rudder. The final record (fig. 30) was taken at approximately 468 miles per hour true speed (or 410 indicated) about a minute before the rudder was destroyed. It is seen that the element, B, which was situated near the center of the destroyed area, shows an almost pure sine wave. The frequency is by count 146 cycles per second.
